GASIL

General Aviation Safety Information Leaflet

Issue no. 7 of 2011

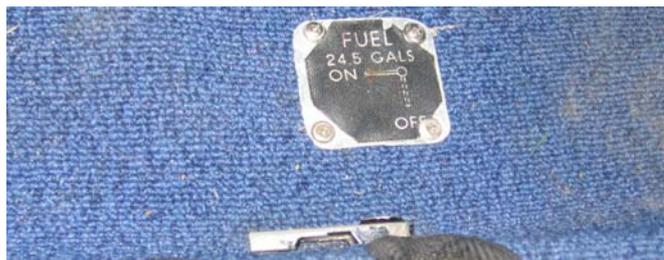
The writer was specifically referring to Cessna 150/152 types. If the fuel cock is selected ON in such types, or to BOTH on 172s or similar, and the aircraft is parked on a slight slope, gravity is likely to induce a flow from the high tank to a lower one, and possibly out through that tank's vent pipe.

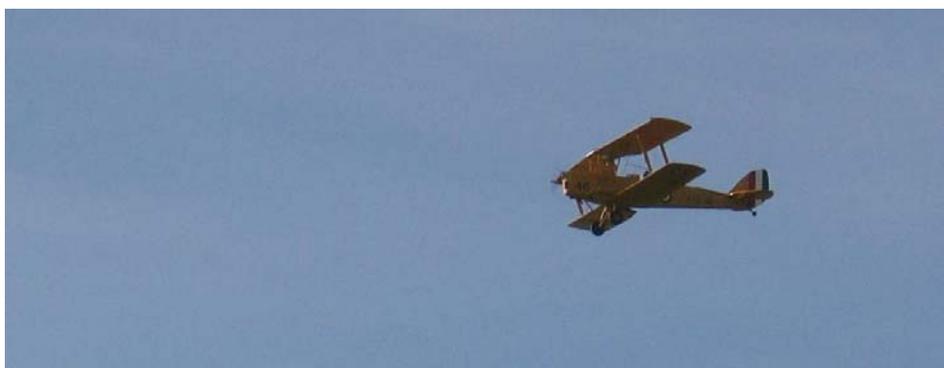
However, despite the fact that the Rules of the Air are by far the most important part of any course of study for a pilot's licence, some qualified pilots seem to be unaware of them, or how to apply them. Even determining who has the right of way is sometimes forgotten. It seems relatively easy to remember that in a converging situation, flying machines give way to airships, which give way to gliders which in turn give way to balloons. However, when two similar types converge, knowledge of the Rules seems to be less widespread. Not only do some pilots who should give way just not do so, but instances continue to occur when a pilot seeing another aircraft through the left side of his windscreen believes he should give way and starts to take avoiding action as soon as he sees it.

Rule 8(5) states that the aircraft with right of way should maintain its course and speed (nothing said about altitude) and that is so that the aircraft which has to give way can take simple avoiding action, as it must. If both aircraft start to manoeuvre, it confuses the situation and can lead to the very collision the Rules are intended to prevent. Of course, if the aircraft which ought to give way doesn't, nothing absolves the commanders of all aircraft involved from doing all they can to prevent a collision. The one with right of way has to do something, and it is logical that the pilot keeps the other aircraft in sight in case it suddenly makes a move. Descending to pass under the aircraft which should have given way is probably the best way to do this. Perhaps to allow such last-minute manoeuvring to be performed safely, Rule 8(4) forbids the aircraft which is supposed to give way from passing over or under the other one, another Rule which is not always complied with.

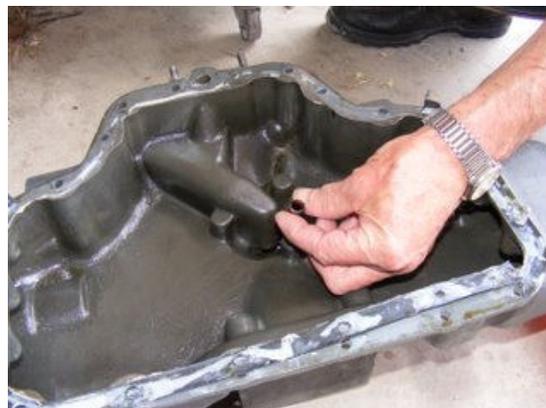
However, as with many good ideas, there is a possible downside to the idea. We are grateful to the reader who reported that some three hours after the pilot had topped up his oil, he realised that the tube he kept for oil replenishment was missing. It had to be inside the engine, and the engineers stripped the engine to find it. Luckily it was found in the oil chest still in one piece, partially wedged in the scavenge suction pipe, and was recovered intact.

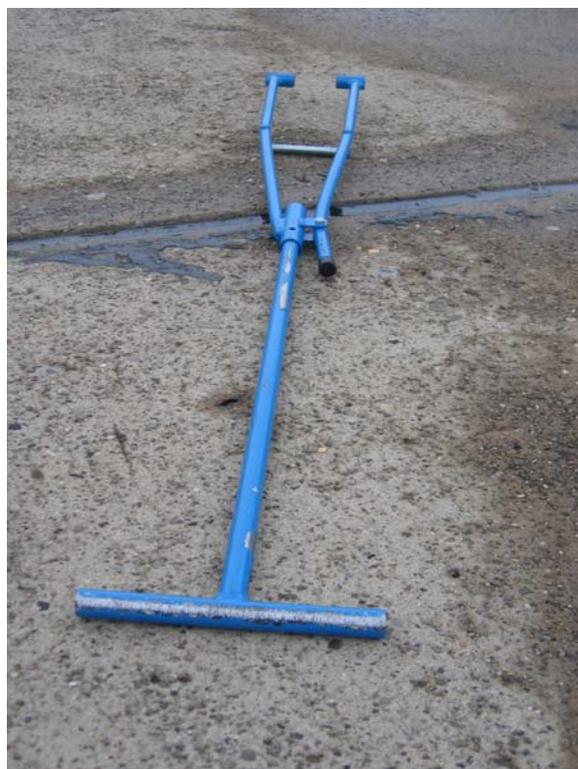
A picture tells

Careful study of the photograph should allow readers to see that the paint on the handle has been removed, perhaps worn away. Many will probably come to their own conclusions, but details as to how this came about, and the further possibly surprising implications, can be found on the last page.

Shortly after take-off, which seemed completely uneventful, the pilot changed frequency to his home base, whose air traffic controller informed him that he seemed to have taken off with the towbar still attached to the nosewheel. The towbar was reportedly still attached as he joined the traffic pattern and landed, again apparently uneventfully. It was still attached when the aircraft was brought to a halt, although the paint and several microns of metal had been worn through from contact with the concrete runways and taxiways.

As previously reported in these pages, similar incidents have resulted in considerable damage to engine and propeller when the towbar came into contact with rough ground or gaps in concrete paving. However, in this case the inspecting engineer was extremely surprised and pleased to note that neither the towbar nor the propeller showed any signs of having contacted each other. The only indications on the aeroplane were barely imperceptible scuff marks on the nosewheel tyre from the spring on the towbar.

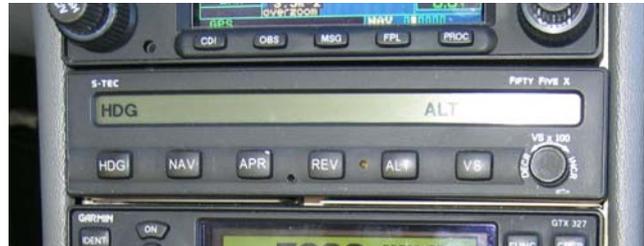
File photo

The investigation was unable to determine why control was lost, but draws attention to the aircraft's never exceed speed, V_{NE} . The radar map enclosed with the report suggests that the aircraft was flying close to that speed before and during its cleared descent. The investigation concludes that the autopilot was almost certainly engaged prior to the loss of control, and points out that the cloud and darkness would have given the pilot no external visual references to assist in regaining control once the autopilot had disengaged.
